Carrying Capacity Study of Teesta Basin in Sikkim

Volume-II

**LAND ENVIRONMENT -
GEOPHYSICAL ENVIRONMENT**

**CENTRE FOR INTER-DISCIPLINARY STUDIES OF
MOUNTAIN & HILL ENVIRONMENT
CISMHE UNIVERSITY OF DELHI, DELHI**

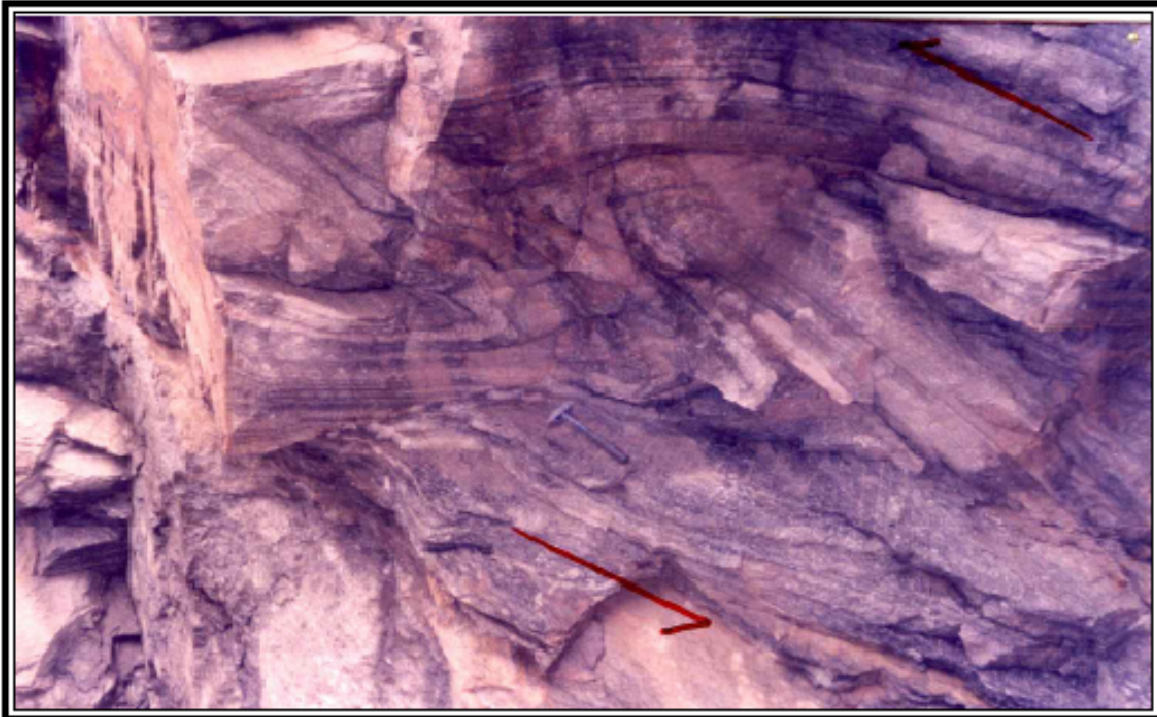
Plate 1.3 S-shaped folds on the limb of north plunging antiform

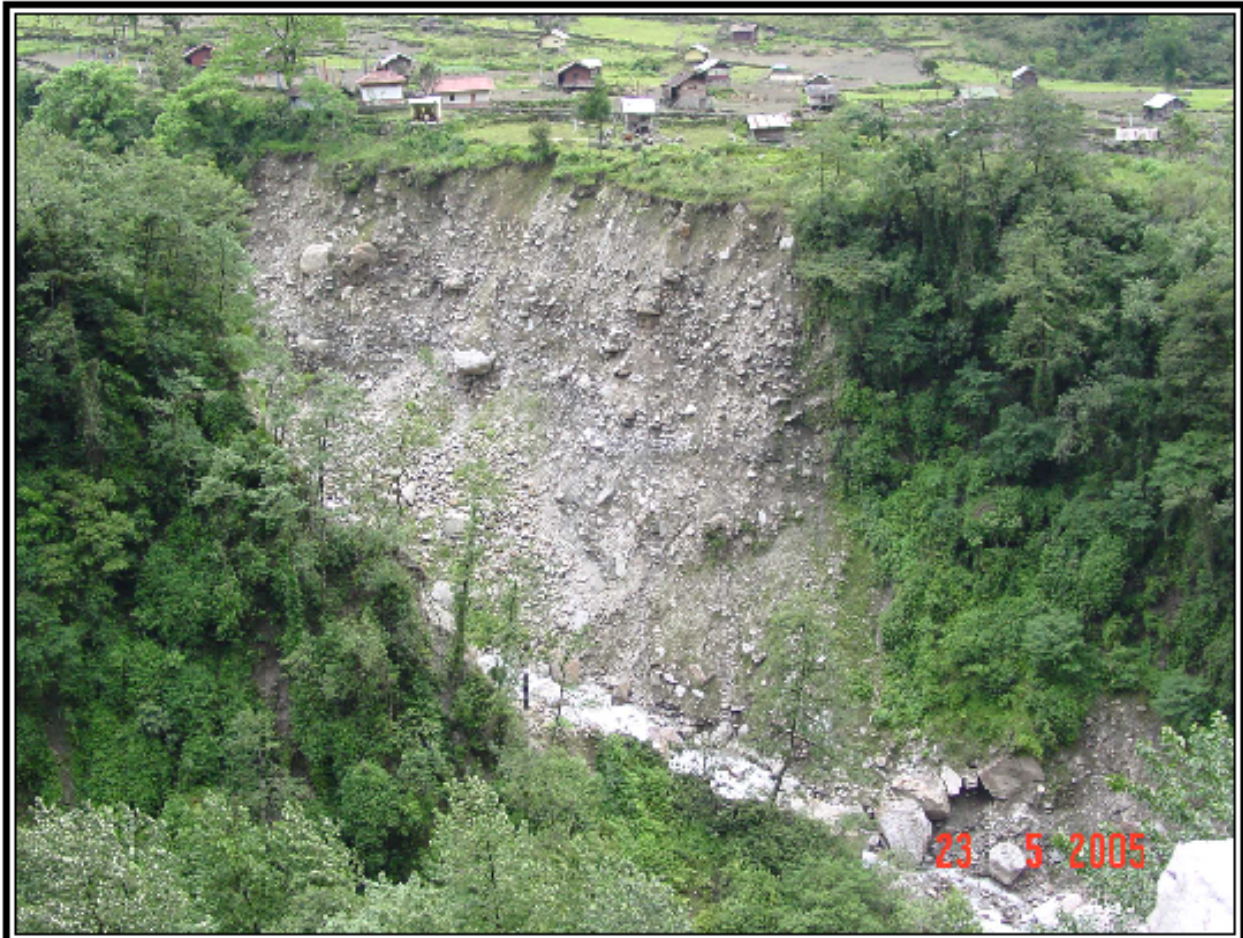
Plate 1.10 Collapse of Terrace on the left bank of Lachung and Creeping of settlement on it

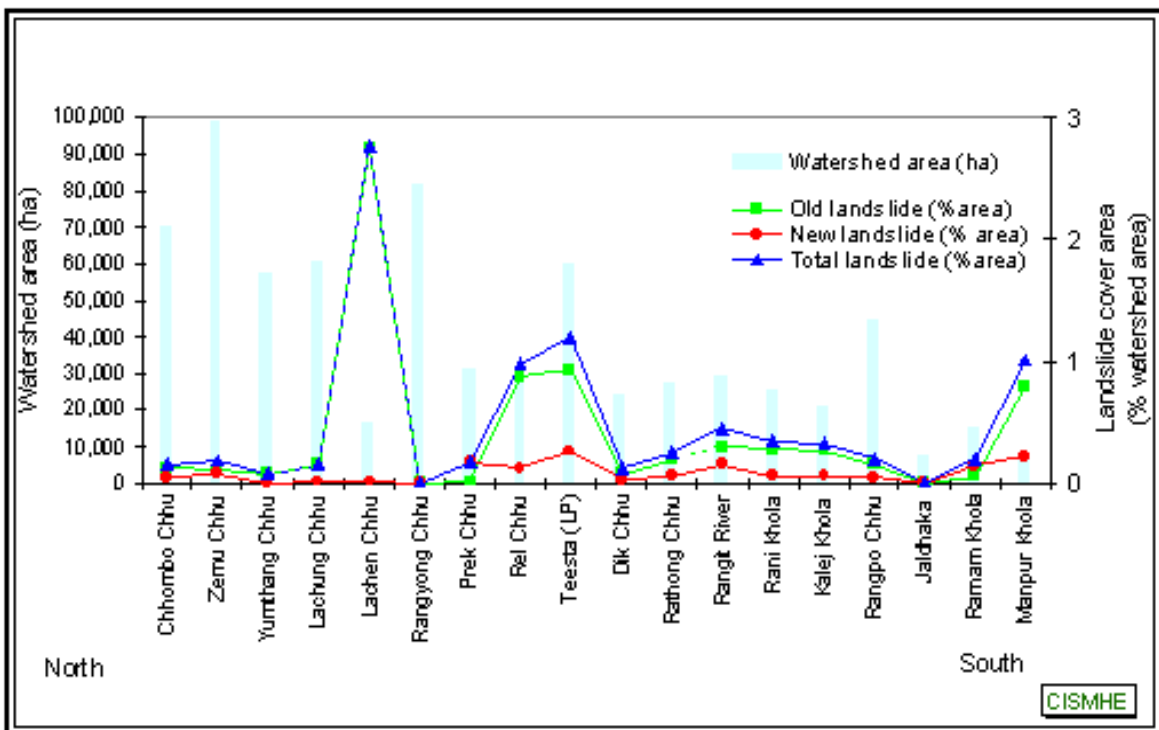
Fig. 2.3 Planimetric area of the watersheds (shown as bars) and the area covered by landslides (lines with dots) given in percent of the watershed area

Figure 2.3 shows the area covered by landslides (old, new and total) expressed as per cent of the watershed area. The planimetric area does not represent the exact area covered by a landslide because of topography. For instance, if there are two landslides of same base then the slide on the steeper slope covering a larger elevational range will have lesser planimetric area compared to that on a gentle slope. However, the Fig.2.3 provides some useful information to have a comparative study between two watersheds. As evident from this figure, Chhombo Chhu, Zemu Chhu, Rangyong Chhu watersheds have large geographic areas of which < 0.5% are covered with landslides; rest of the area covered with moraines. Lachen Chhu watershed covers a small area but 3% of this watershed is covered with old landslides. This watershed represents the right bank slope of Teesta river and is traversed by many streams. This slope is very steep and covered with dense vegetation.

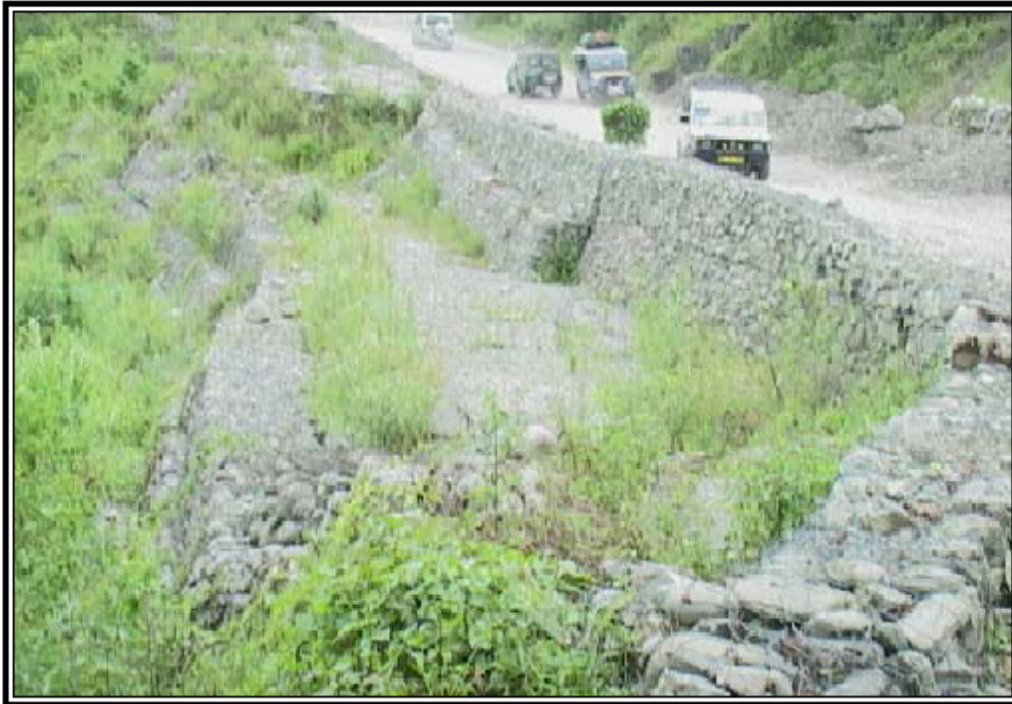
Plate 2.11 Creeping and collapse of the protection wall near Ri Chhu

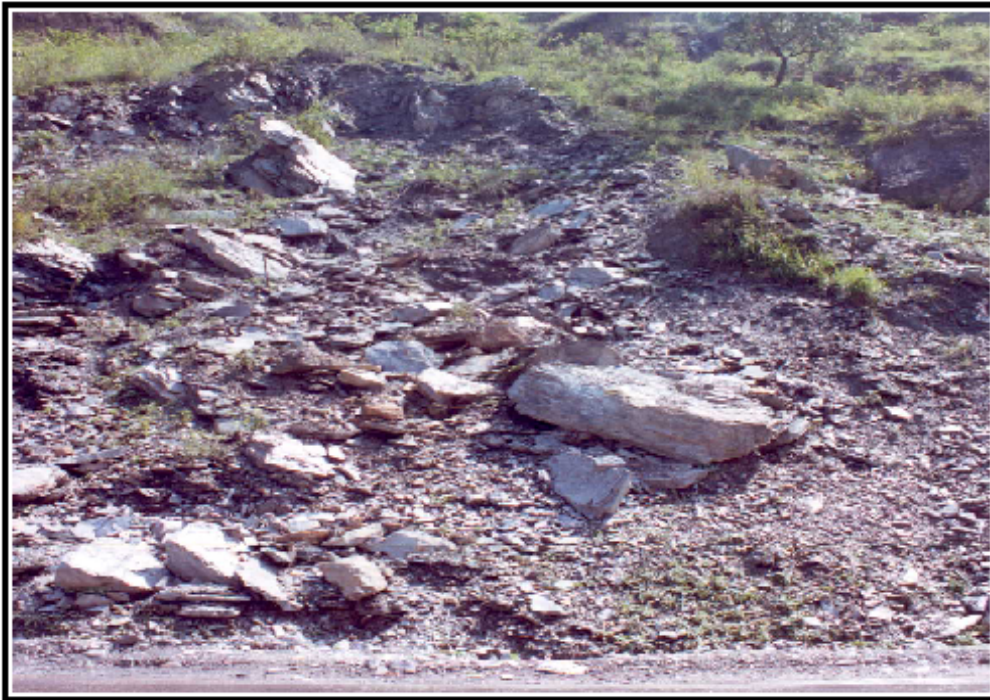
Plate 2.15 Rangpo landslide showing Rock fall and debris flow

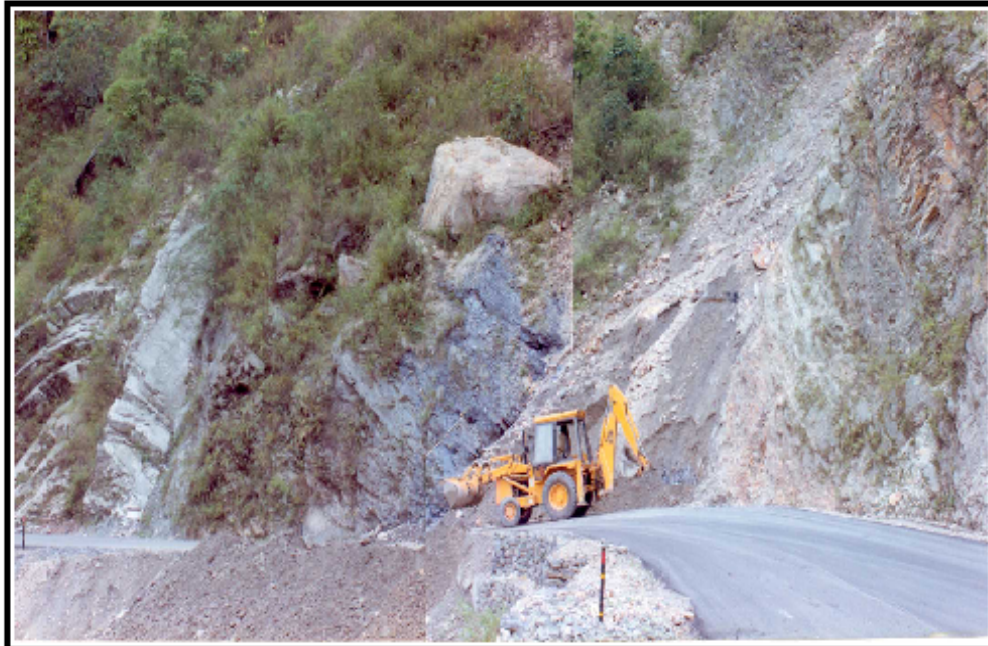
Plate 2.16 Berrick landslide showing a fault propagated fold and the circular failure of carbonaceous phyllite

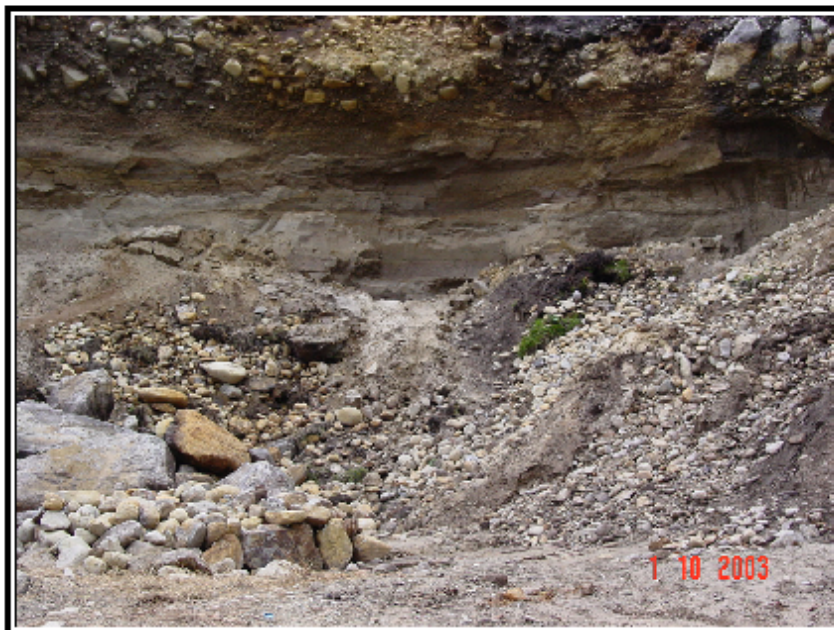
Plate 2.22 Collapse of old depositional landforms due to road building downstream of Thangu

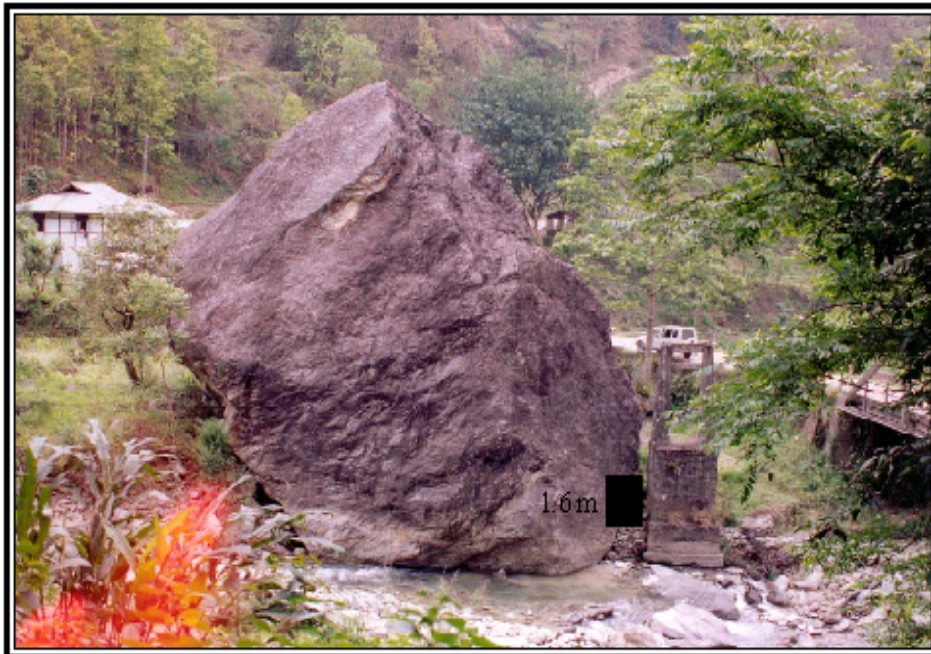
Plate 2.23 Rock fall on the right bank of Rangpo Khola near Mangalbare
